# Manhole Inspection Summary

Manhole # S19Y\_\_015MH

**Location** Address: **1901 ginnalds av**

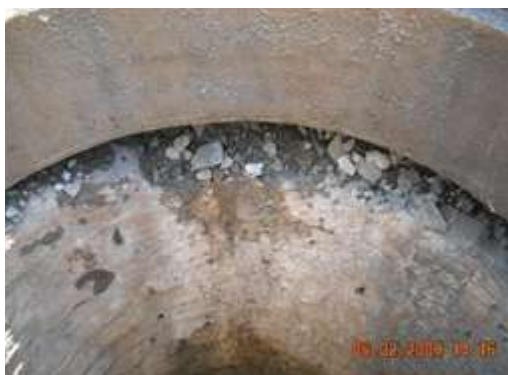
Defect 4

Infiltration: ☐ None ☒ **Joint** ☐ Cracks ☐ Mortar ☐ Roots ☐ Wall

infiltration @ corbel/frame joint

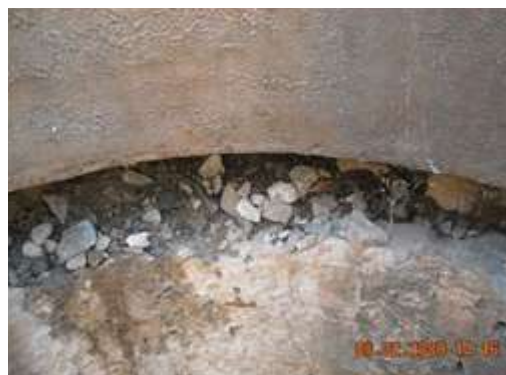
Defect 3

Condition: ☐ Sound ☐ Cracked ☐ Root Intrusion ☐ Loose Brick ☒ **Deteriorated**

deteriorated corbel bricks

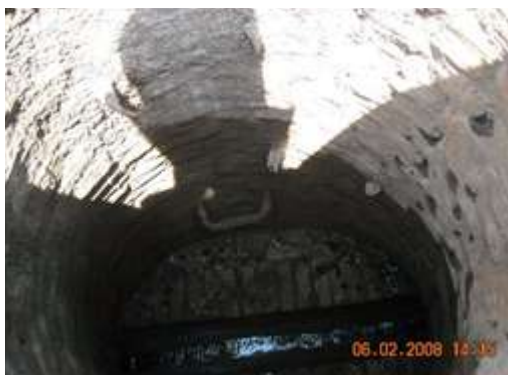
Defect 2

**Steps** Count: **1** Missing: **2** ☒ **Corroded**

corroded & missing steps

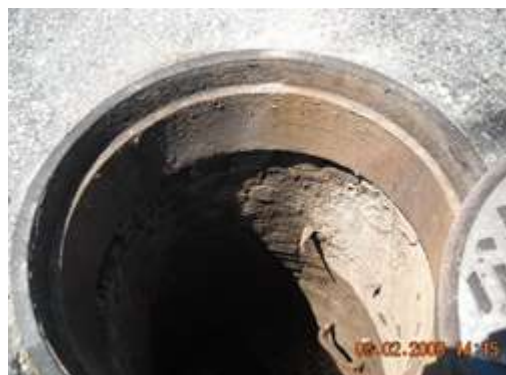
Defect 1

**Frame** Offset: **0** (in.) Condition: ☐ Sound ☐ Cracked ☒ **Leaks**

frame leaks

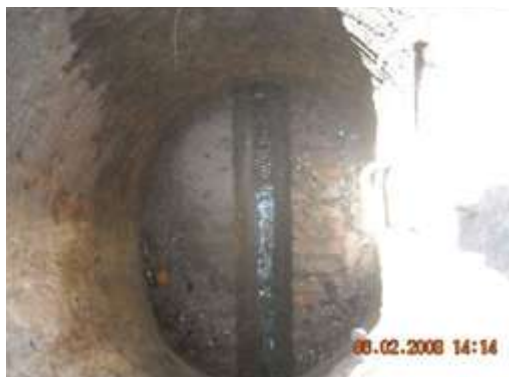
defect

Infiltration: ☐ None ☐ Joint ☐ Cracks ☐ Mortar ☐ Roots ☒ **Wall**

barrel flow wall
